**Village of Cimarron, New Mexico
Municipal Water System Improvements
Preliminary Engineering Report**

Prepared for the
Village of Cimarron, New Mexico

Prepared by Nolte Associates, Inc.
Colorado Springs, CO
Revised February 8, 2008

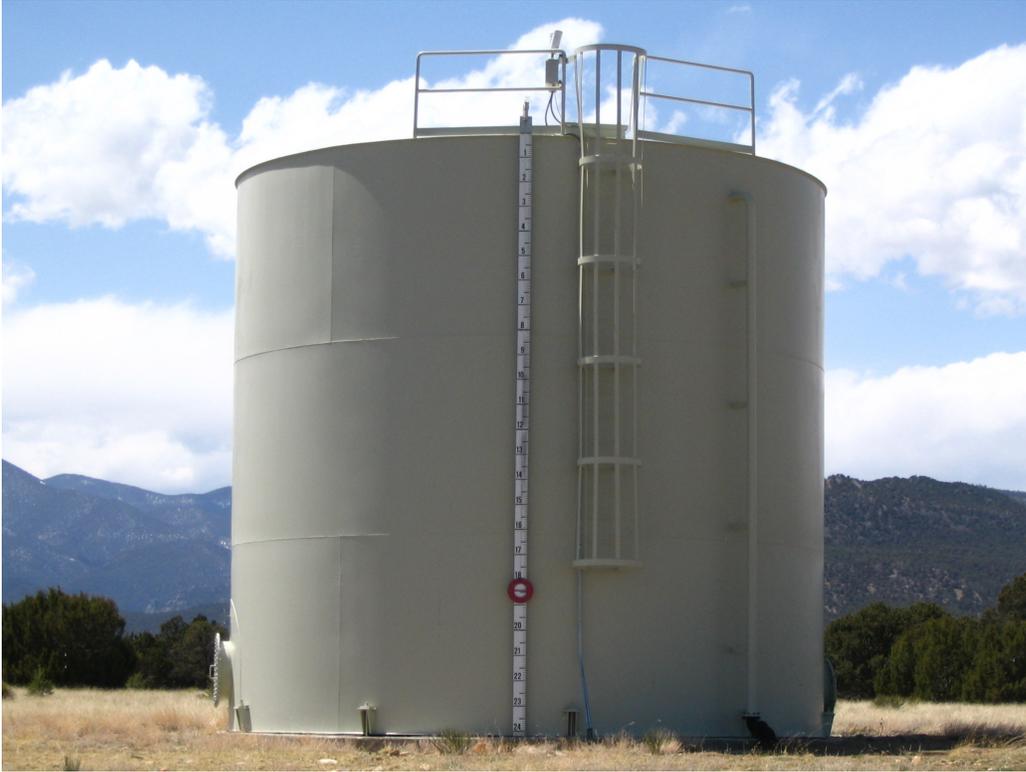
Figure 5 - Raw Water Tank

More water can be processed through the existing facilities than the Village demands as can be seen in the production chart located in Appendix C. Excess water fills the raw water storage tank until reaching the overflow height, at which point the excess is wasted to the backwash pond. This wasting sometimes occurs because of the difficulty accessing the water treatment plant experienced by the Village operators during adverse weather conditions. At such times, it is difficult to manually open and close valves

Currently the Village is wasting more than 1,000,000 gallons every month on average. This high volume of wasting is due to the lack of automation for shutting off the flow from the Cimarroncito Reservoir to the raw water storage tank and leaks in the water transmission and distribution system.

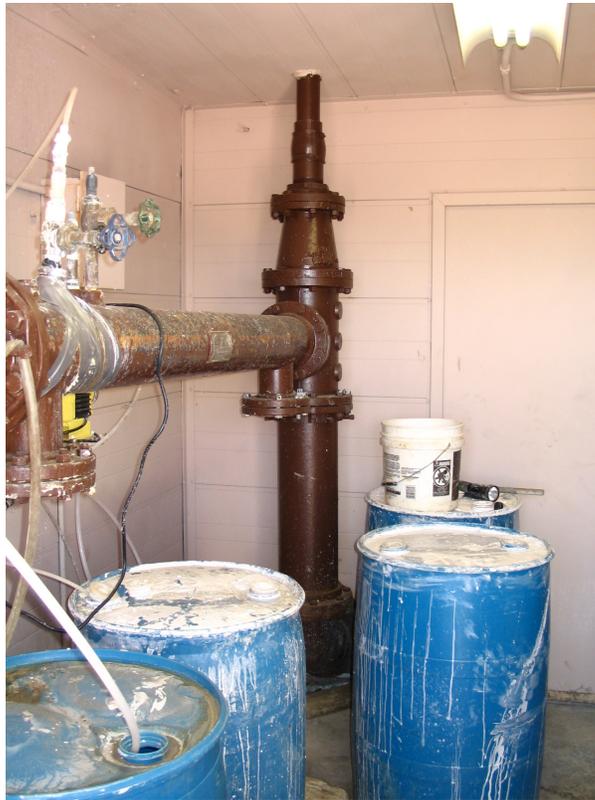
Figure 8 – Lime Injector

The lime injector used for pH control is leaking and also requires attention.

The existing lime injector needs to be replaced due to chemical leakage.

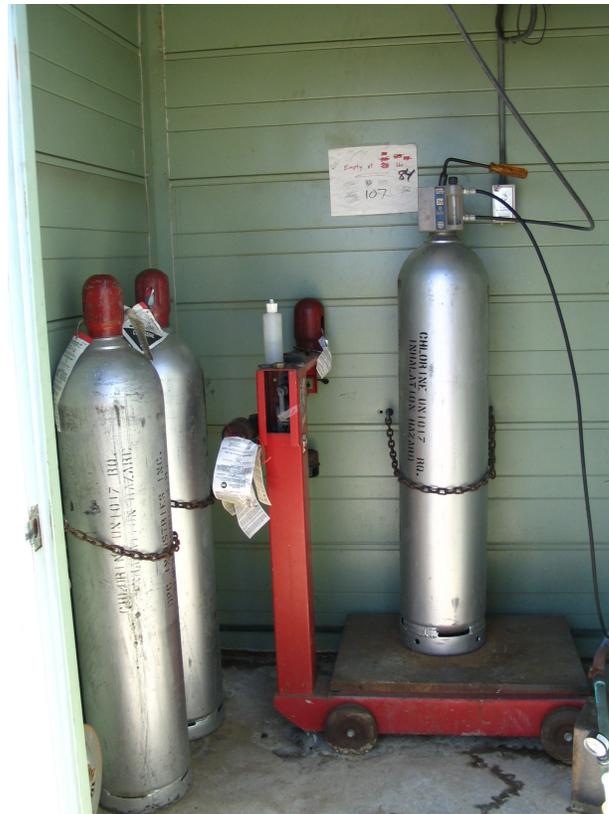
Figure 10 – Chlorine Gas Tank

During the Sanitary Survey completed by the Drinking Water Bureau (DWB), the inspectors observed there were no devices capable of shutting down the chlorine gas tanks in the event of a gas release. DWB recommends installation of a shut-off wrench to be permanently attached to the chlorine tank. At the time of the inspection, in November 2005, the Village did not have a written evacuation plan in the event of a chlorine gas leak, which the DWB recommends. They also observed that the chlorine room does not have

a panic bar on the door for easy escape, which is an OSHA violation. Additionally, the DWB suggests the installation of an alarm capable of informing the operator when there is an interruption in chlorine feed.

The operators have investigated the cost and opportunity to use Sodium Hypochlorite for disinfection rather than chlorine gas, but the costs and ordering time are greater. Currently, the Village obtains chlorine gas from Raton, NM, which is less than an hour away and from a supplier who is able to deliver the chlorine quickly and cost effectively. Sodium hypochlorite could be supplied from Albuquerque, which is three hours away and require multiple weeks of lead time before the chemical transport could be delivered. Using sodium hypochlorite provides improved safety conditions for the operators compared to chlorine gas.

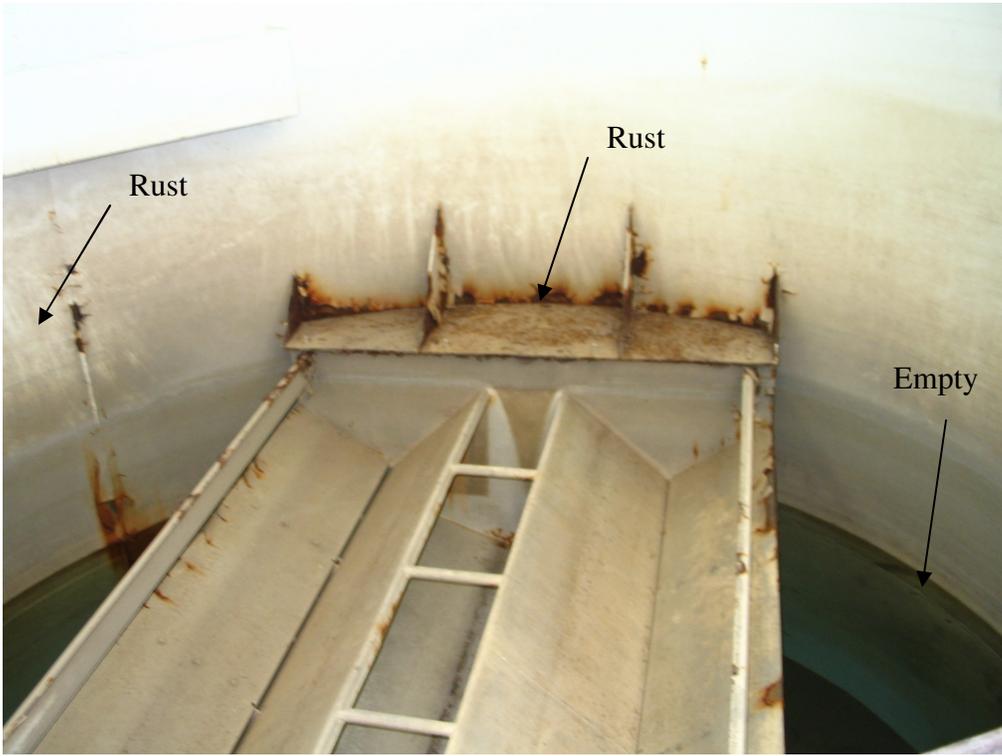
Figure 11 – Steel Filter

The 13-year old circular steel gravity filter has not been in operation for many years. With this filter out of service, there is no redundancy to ensure water treatment in the event that the concrete filter should fail. If this filter were to fail, the raw water storage tank can supply untreated water to the distribution system through emergency bypass piping, at which point the Village must issue a boil water alert.

The plant operator has not been able to fully drain the steel filter, which prohibited examination of the current media during an inspection conducted by Siemens personnel in the summer of 2007. The media has not been replaced since it was installed in 1995 and is probably in need of replacement. Additionally, a Siemens representative voiced concern that this filter, although appearing to be in good structural condition, is showing areas of paint failure and signs of surface corrosion and rust.

To bring the existing Tonka filter back online, the water and existing media will need to be removed and the inside and outside of the filter sandblasted to “Near White Metal” condition. This will alleviate the rust and corrosion that is currently evident. After sandblasting, the entire tank needs to be epoxy coated to all applicable AWWA standards. New air wash grids, media retaining nozzles, and media should be installed and the tank brought to operational condition. After the preparation work has been completed, the tank will be brought online as the primary treatment filter.

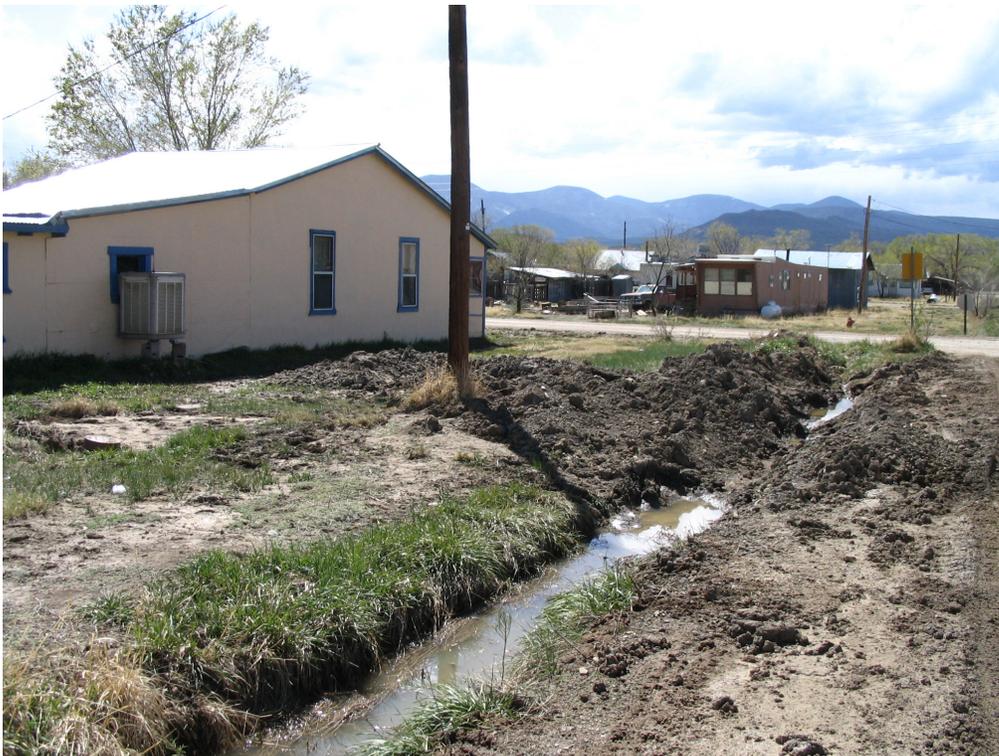
Figure 16 – Damage Caused by Water Main Failure

Many areas of the distribution network are failing and in need of repair. Currently, the Village is interested in replacing the following segments of pipe:

Repair failing segments of the water distribution network as described above in the “Existing Central Facilities” Section of this report.

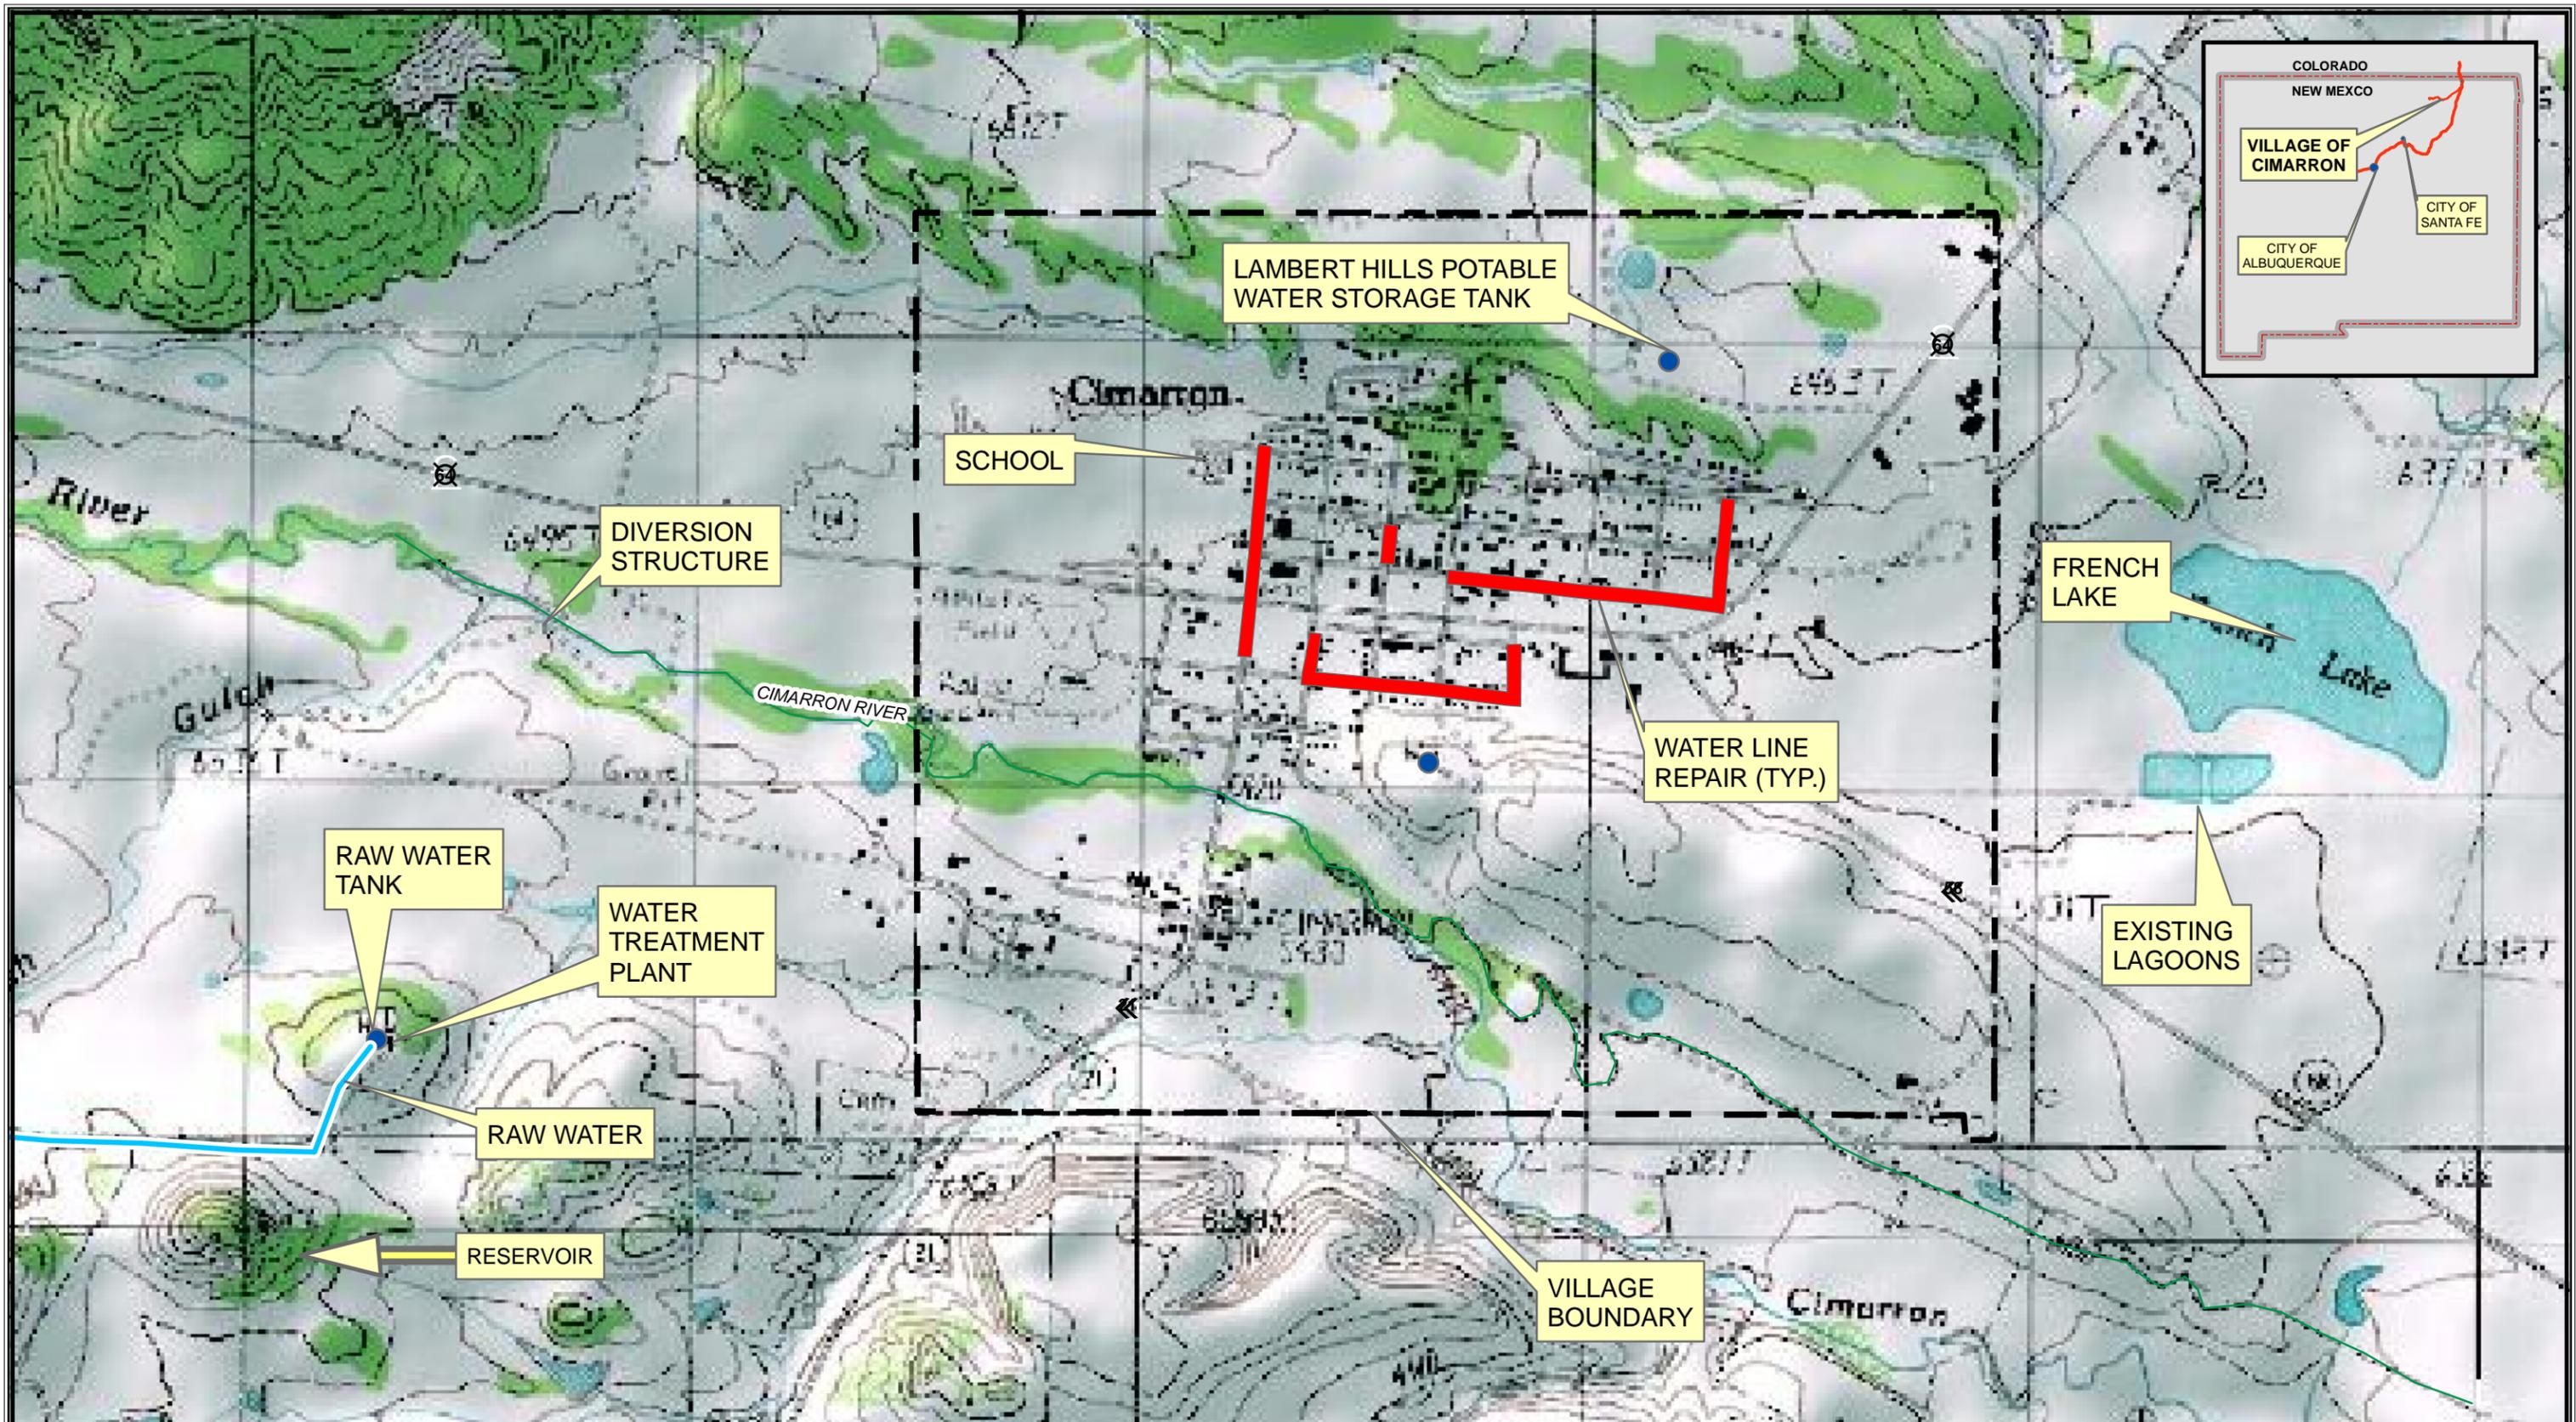
WATER VICINITY MAP

- A Waterline replacement on Collinson Ave. from 11th Street north across Highway 64 to 9th Street, as well as between the High School entrance and 7th Street. The repair will remediate approximately 900 feet including appurtenances and service lines.

- B Waterline replacement on Lafayette Ave. from 9th Street to 7th Street. The repair will remediate approximately 850 feet including appurtenances and service lines.

- C Waterline replacement on 9th Street from Washington Ave. to Lafayette Ave. The repair will remediate approximately 2,000 feet including appurtenances and service lines.

- D New distribution loop and waterline replacement on Euclid Ave. from Highway 64 south to 11th Street, then east on 11th Street to Jefferson Ave., then north on Jefferson to tie into an existing main at Jefferson Ave. and Highway 64. The repair will remediate approximately 2,300 feet including appurtenances and service lines.

This priority has a total estimated cost of \$1,347,000 for repairs A through D plus engineering and miscellaneous fees. Refer to Appendix F for cost breakdown of individual repairs.
